Bluewrist Case Study

Inline 3D Bead Inspection

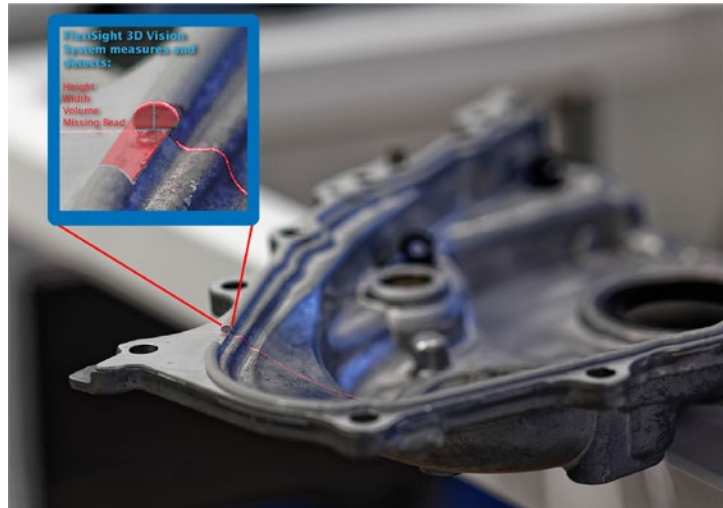
Based on the customer's requirements, a 3D scanning system was suggested to collect the height and width information. The 3D scanner would be mounted to an industrial robot that would move the scanner along the bead. Other configurations were also feasible—for example, the part held by the

robot to be scanned by a fixed camera or having the camera mounted on a linear slide.

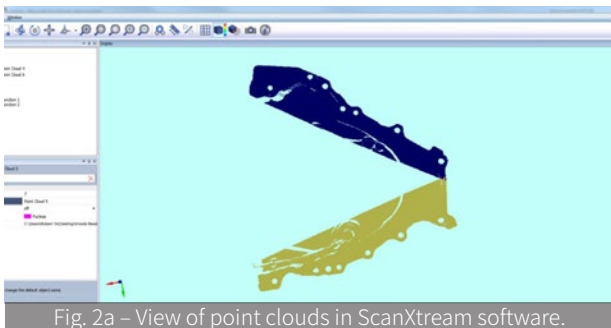
Fig. 2a – View of point clouds in ScanXtream software.

One or more point clouds were sent into ScanXstream as shown in Figure 2a. With the CAD model also loaded into the software, the point cloud is automatically aligned to the CAD. If the CAD model was not available, the user could setup alignment based on the best fit of multiple features. Then these point clouds would be filtered to get the point clouds of the bead (Figure 2b).

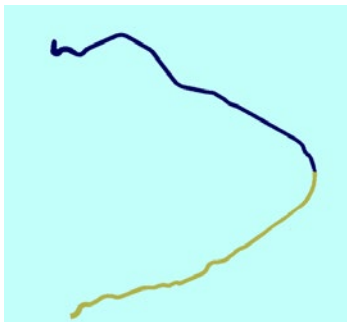
Fig. 2b – Filtered point clouds for bead inspection.

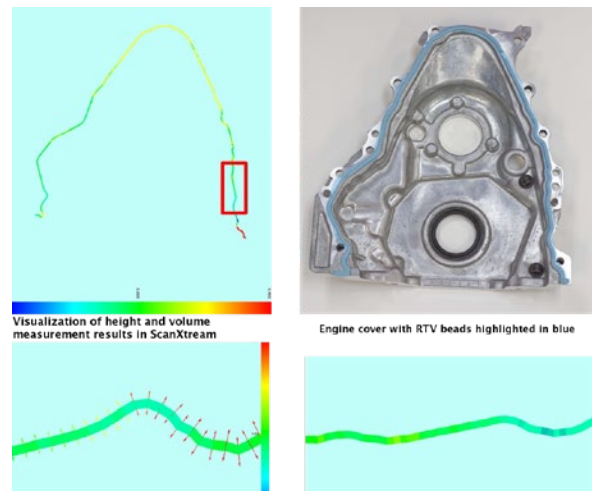
In automatic mode, ScanXtream will send the inspection result (pass/fail) with coordinates of the failing checking points to comXtream for reporting purposes. However, within ScanXtream, the user can visualize the current or previous inspection results.
